derbyshire surveyors

Chartered Surveyors, Valuers and Energy Assessors

BUILDING SURVEY REPORT

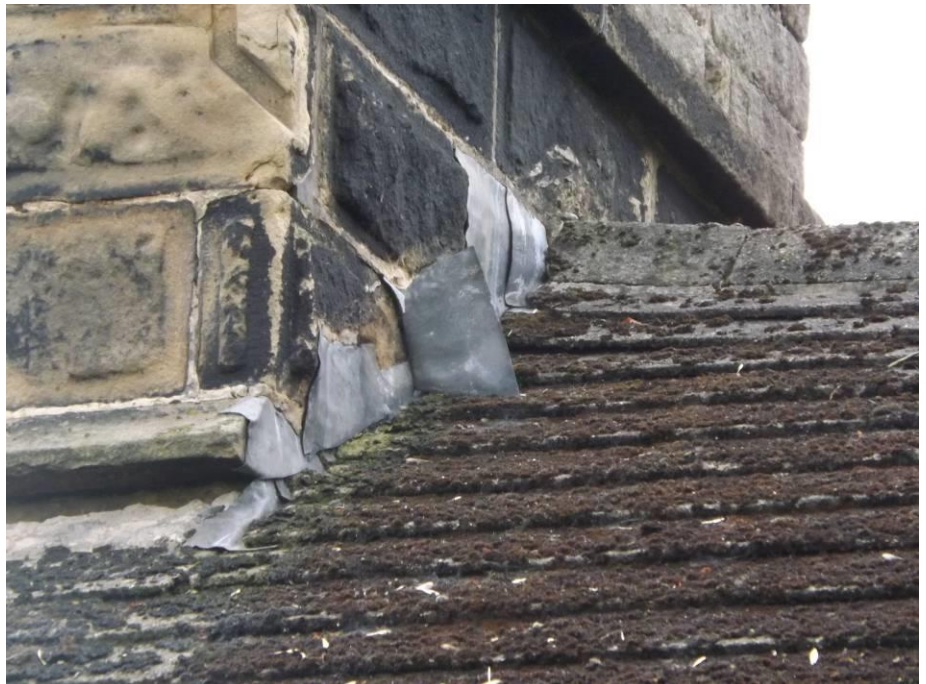
Lead flashings have been utilised at the base of the stacks where the chimneys meet the roof finish. Part of the over flashing at the rear of the right hand stack is lifted and requires refixing. It is essential that flashings are kept in good condition at all times to prevent damp penetration from occurring.

Loose chimney stack flashing

Redundant chimney flues should be capped and/or ventilated as necessary to minimise the possibility of dampness and associated defects internally.

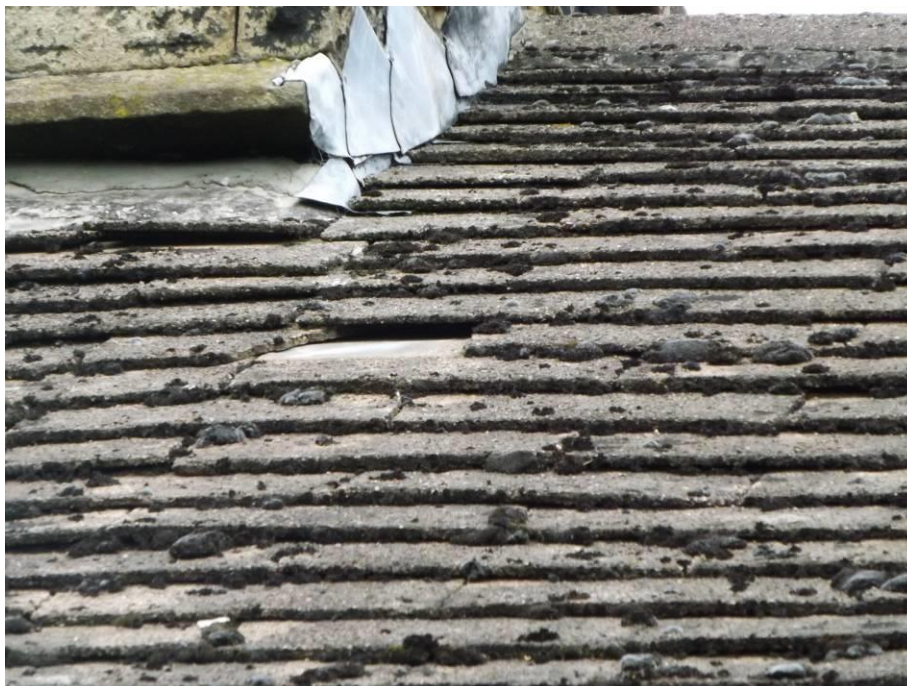
There are signs of deterioration to the main roof covering including slipped or broken tiles.

Slipped roof tile

ACTION: Obtain quotations from competent building contractors for the repairs required to the main roof covering.

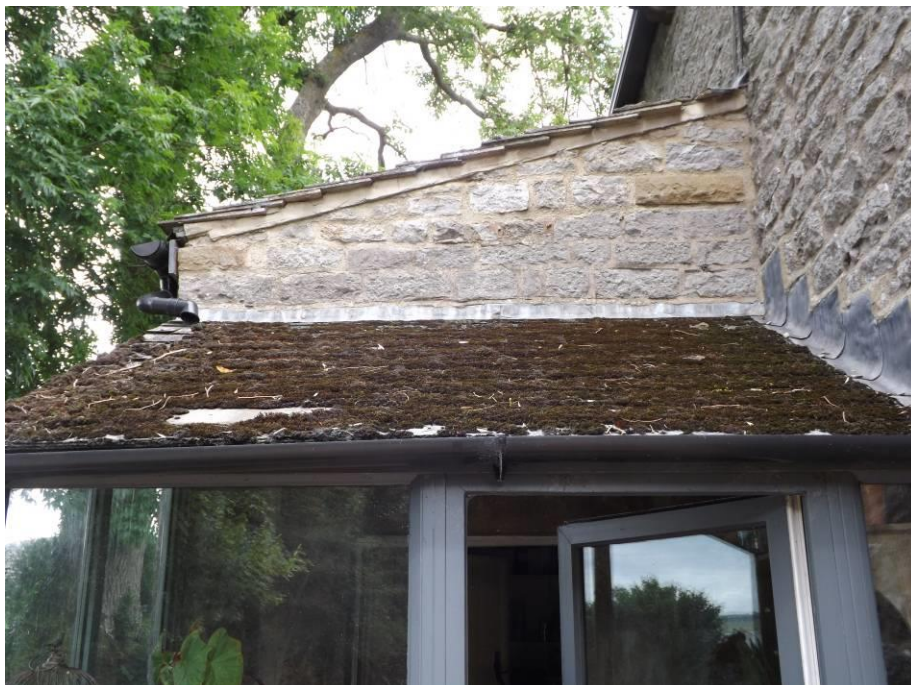
Moss is accumulating on the roof surfaces. This should be carefully removed as it tends to retain moisture which can cause damage to the roof coverings.

Moss on entrance porch roof

ACTION: Obtain quotations from competent building contractors for the repairs required to the secondary roof coverings.

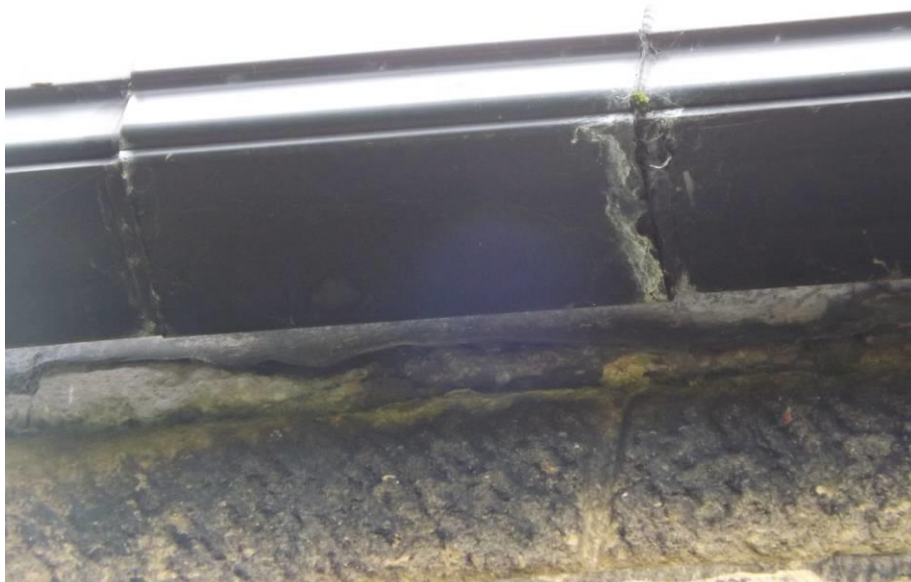
A minor overhaul is required to deal with leaking joints and loose fixings. At the same time alignment to sections of the guttering could be improved.

Leaking gutter joint

ACTION: Obtain quotations from competent building contractors for the repairs required to the rainwater fittings.

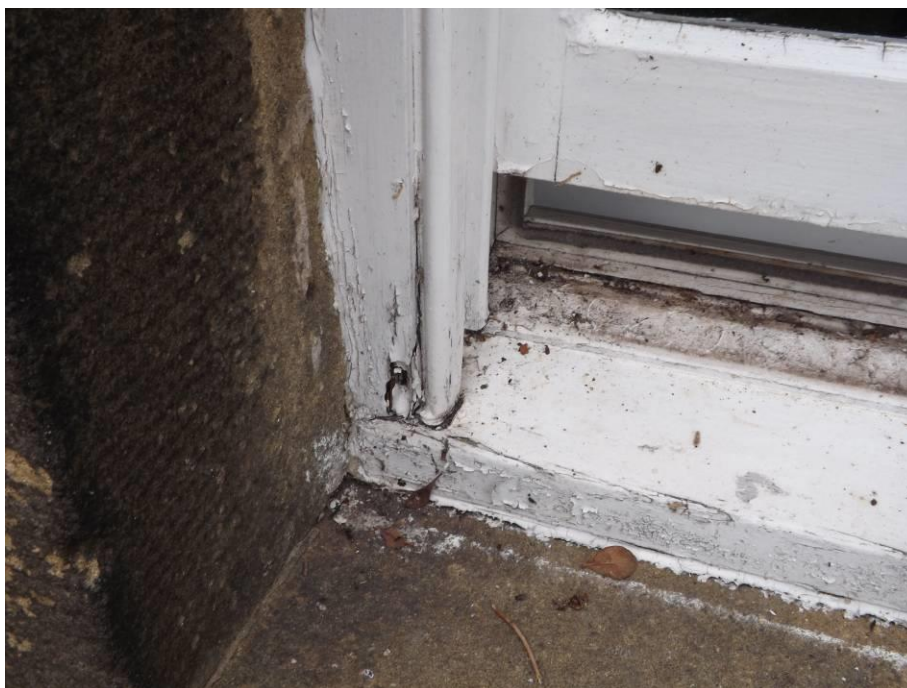
Rot to window joinery

ACTION: Obtain quotations from competent contractors for the repair or replacement of the exterior joinery.

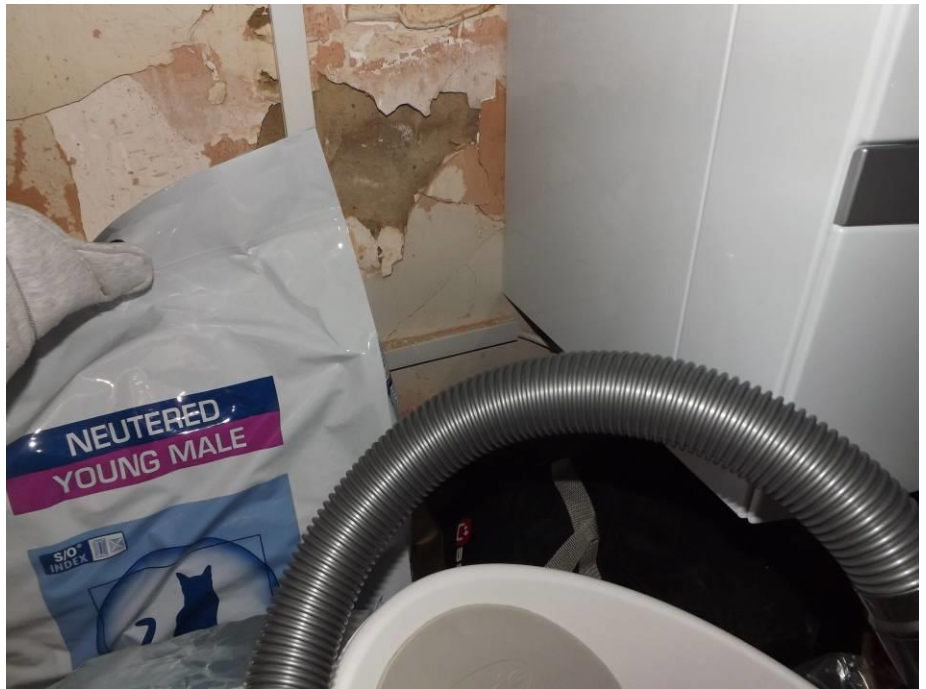
It is probable that there is residual dampness behind the cement render which has been applied to the inner surfaces of some walls. This can obscure dampness for a time, creating apparently dry wall surfaces in the rooms, but inevitably such coatings have limited durability and the dampness may eventually re-appear.

Dampness to family room

ACTION: Instruct a Property Care Association (PCA) registered specialist damp-proofing contractor to inspect the whole property and report on internal dampness, together with a quotation for appropriate remedial works and allied repairs.

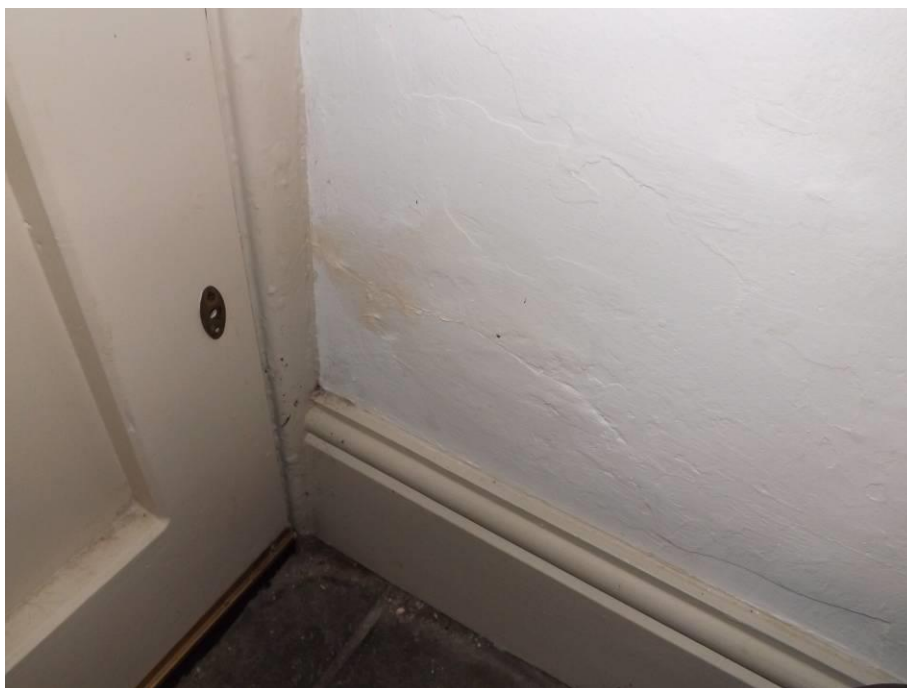
Evidence of penetrating dampness was found, for example within the outside door reveal to the family room. External joints and detailing should be checked and made good where necessary.

Penetrating dampness to door reveal

ACTION: Budget for some repairs to remedy the effects of penetrating dampness.

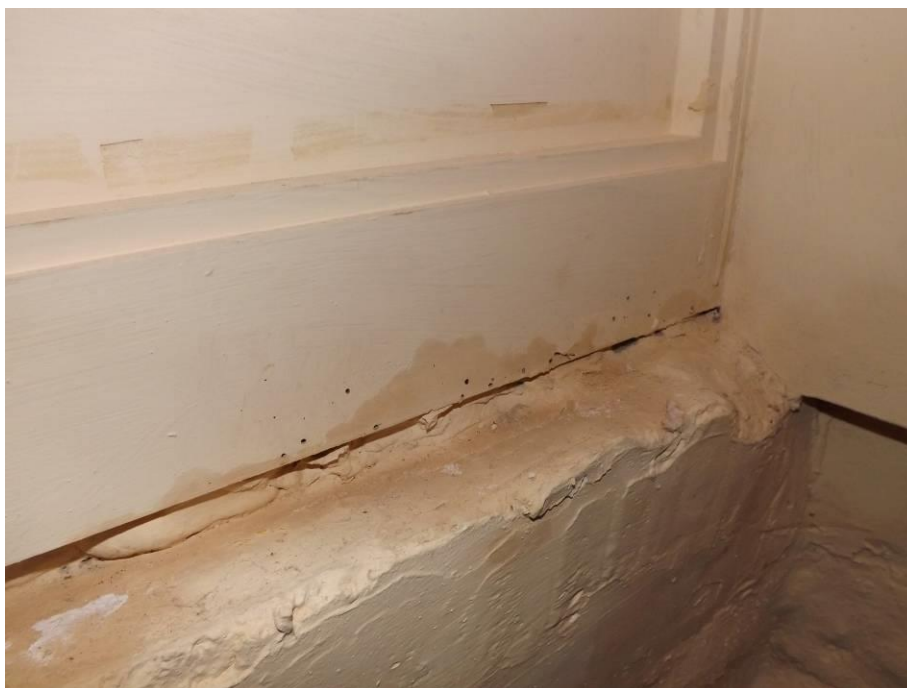
Wood boring beetle infestation

ACTION: Obtain further advice from a Property Care Association (PCA) registered specialist timber contractor if a satisfactory guarantee is not available for the treatment of wood boring beetle infestation.

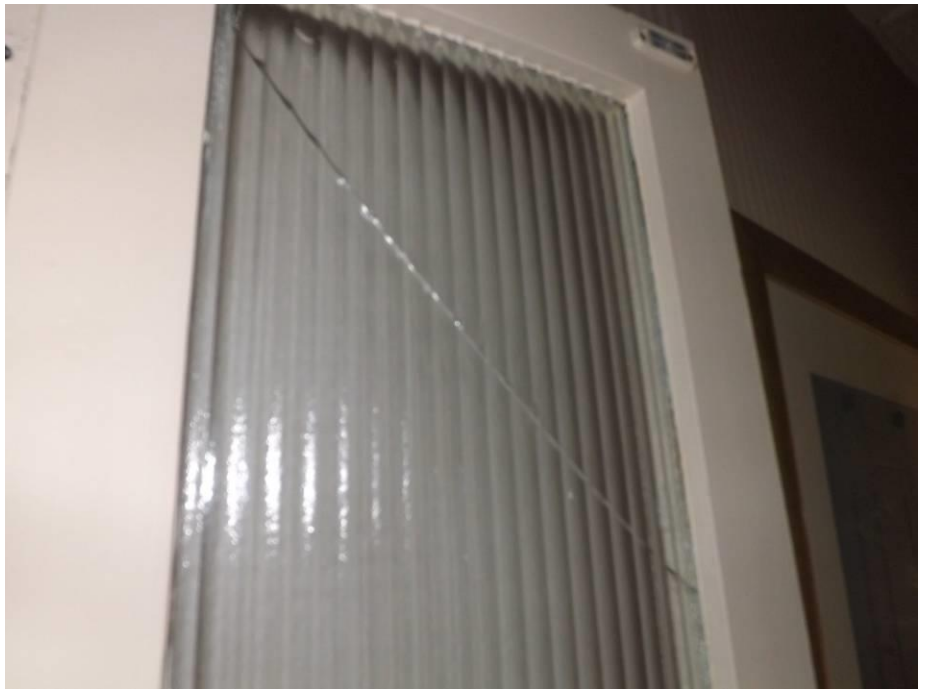
Cracked internal door glazing

ACTION: Budget for some repairs and improvements to the internal joinery.

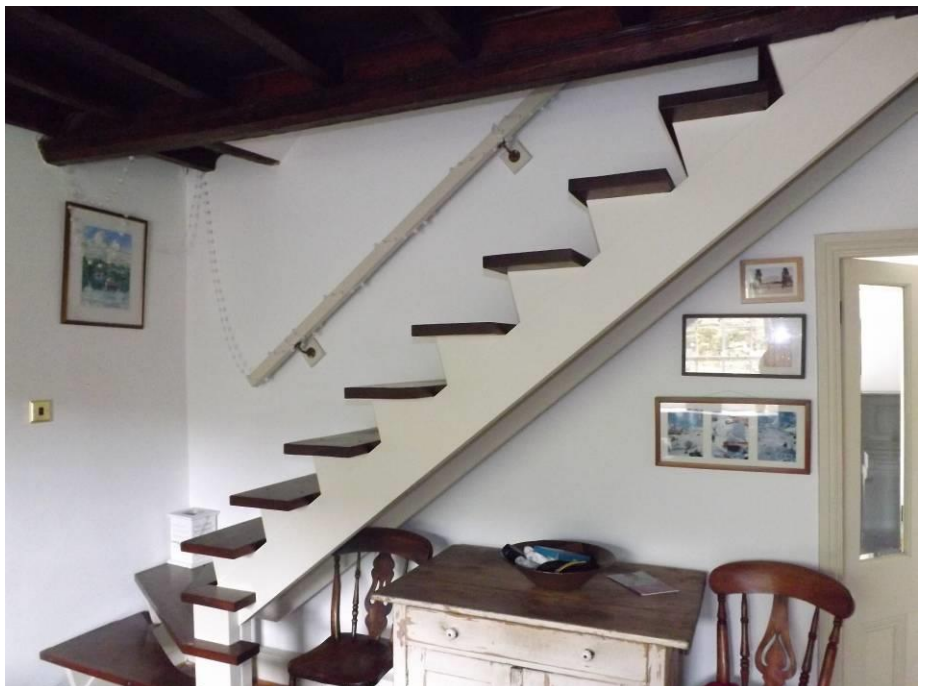
There is no outer balustrade and the open risers do not comply with modern requirements. Upgrading is required for safety reasons.

Open plan design staircase

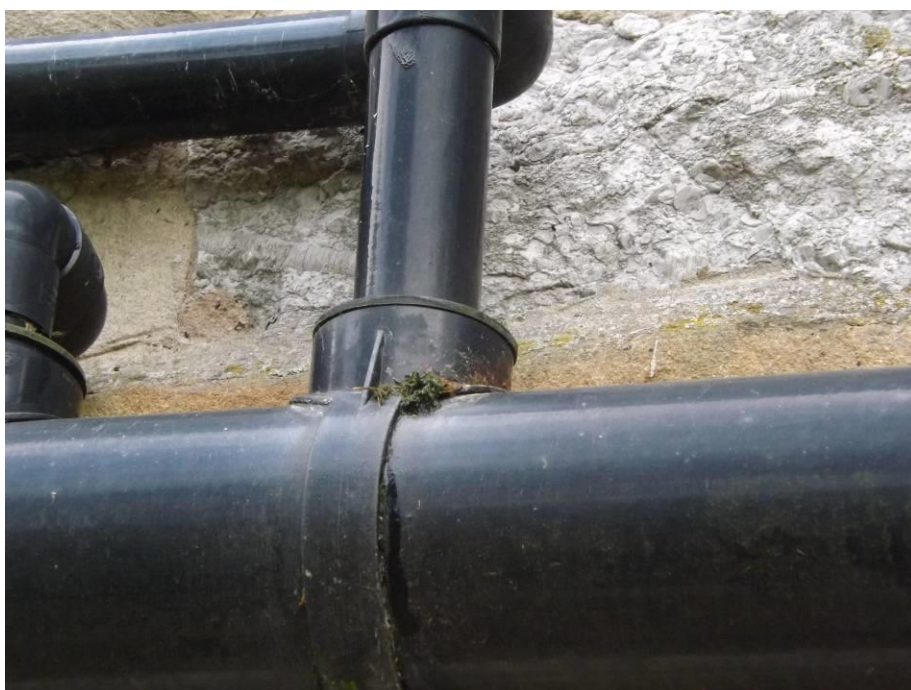
An external uPVC soil and ventilation stack is located at the rear of the main building. The exterior waste water pipes are formed in uPVC. Where not connected into the soil vent stack these discharge into grated gullies. Staining was noted at joints, whilst alignment and fixings could be improved.

Leaking boss connected waste pipe

ACTION: Instruct a specialist drainage contractor to clean and inspect the drains and septic tank and report on their condition, together with a quotation for any necessary work.

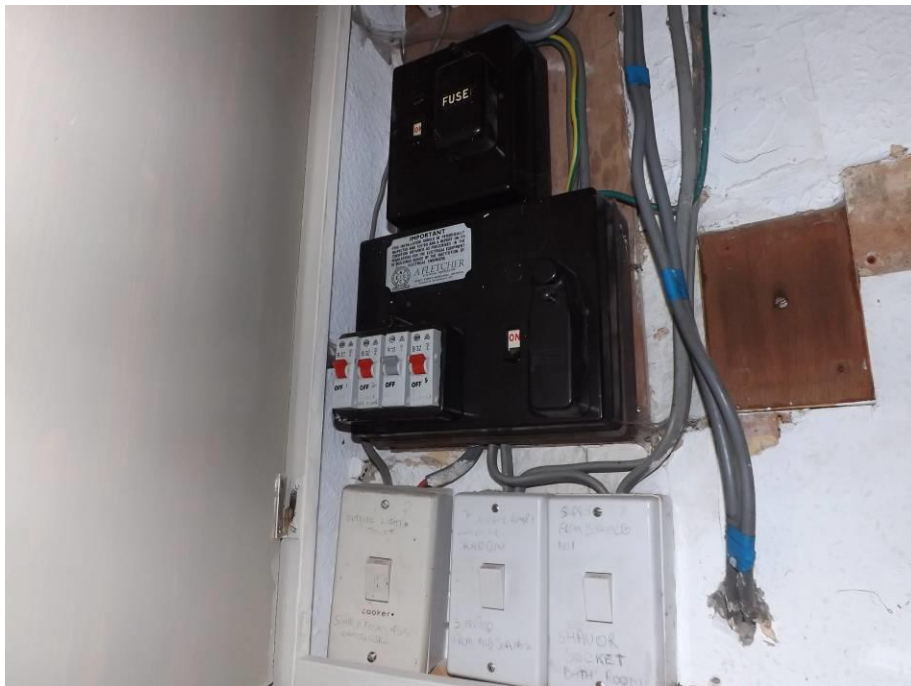
The Institute of Electrical Engineers (IEE) recommend that electrical installations should be tested every 5 years or on change of ownership. The vendors advise that the electrical installation was last inspected in 2012.

Consumer unit to pantry

ACTION: Instruct an NICEIC/ECA registered electrical contractor to test the electrical installation and report on its condition, together with a quotation for any necessary work.

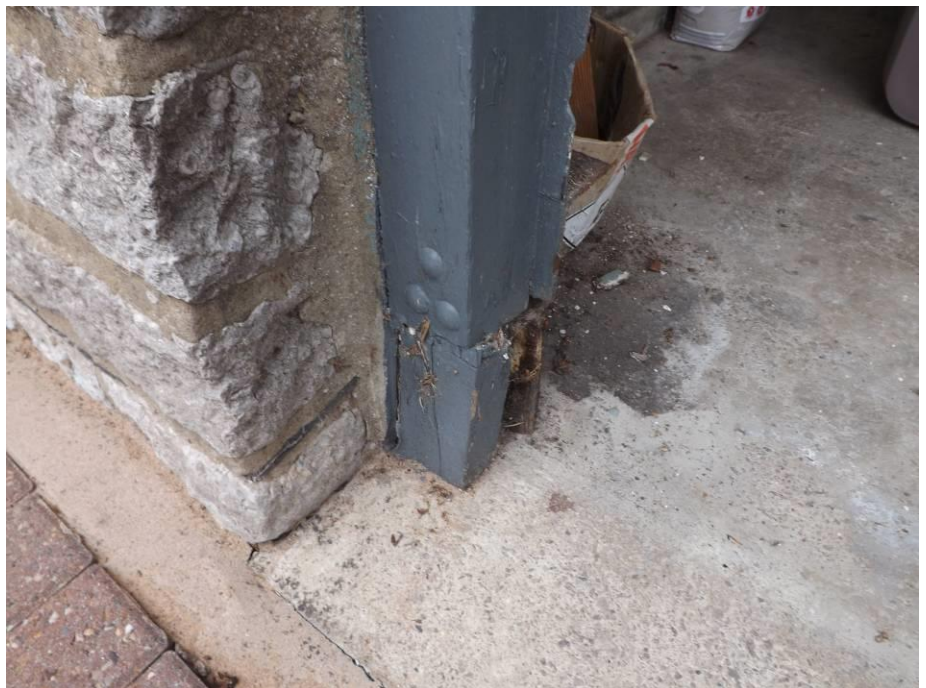
Rot to garage door frame

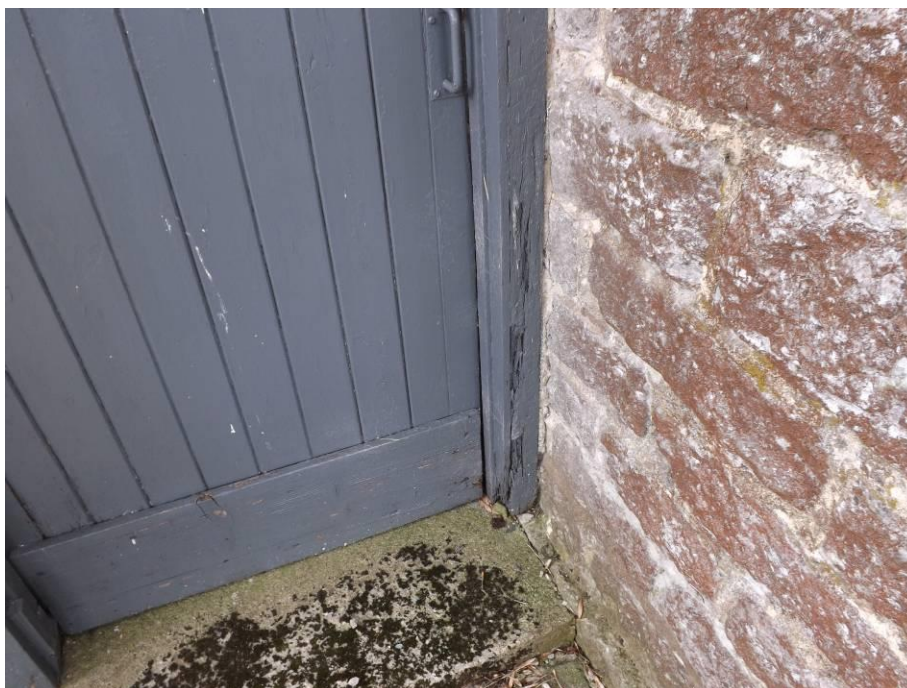
Rot to outside WC door frame

ACTION: Budget for some repairs to the outbuildings.

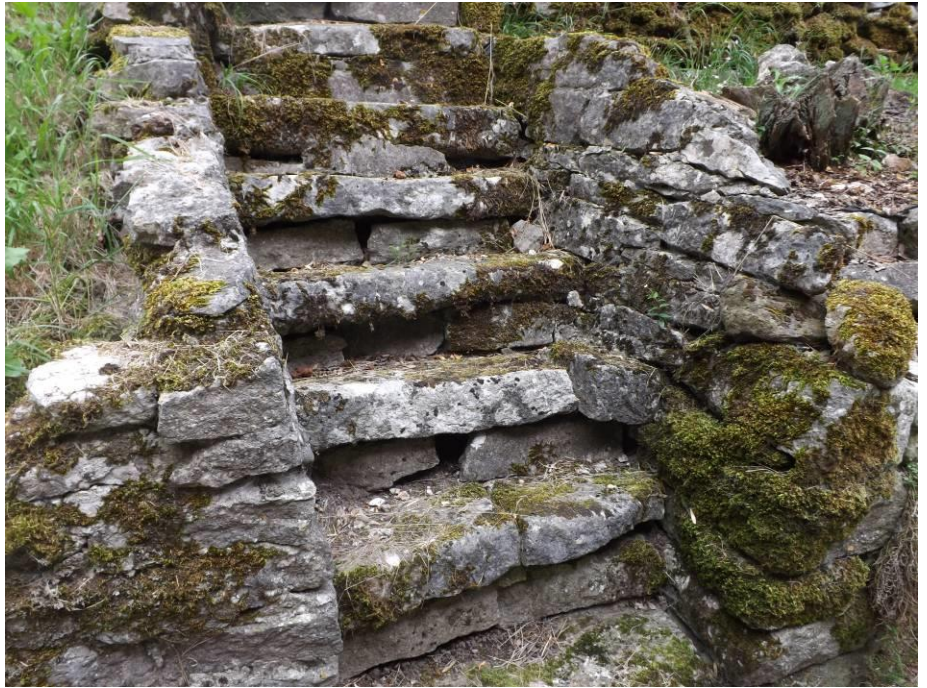
Steps to rear garden

ACTION: Budget for some repairs to the external areas.

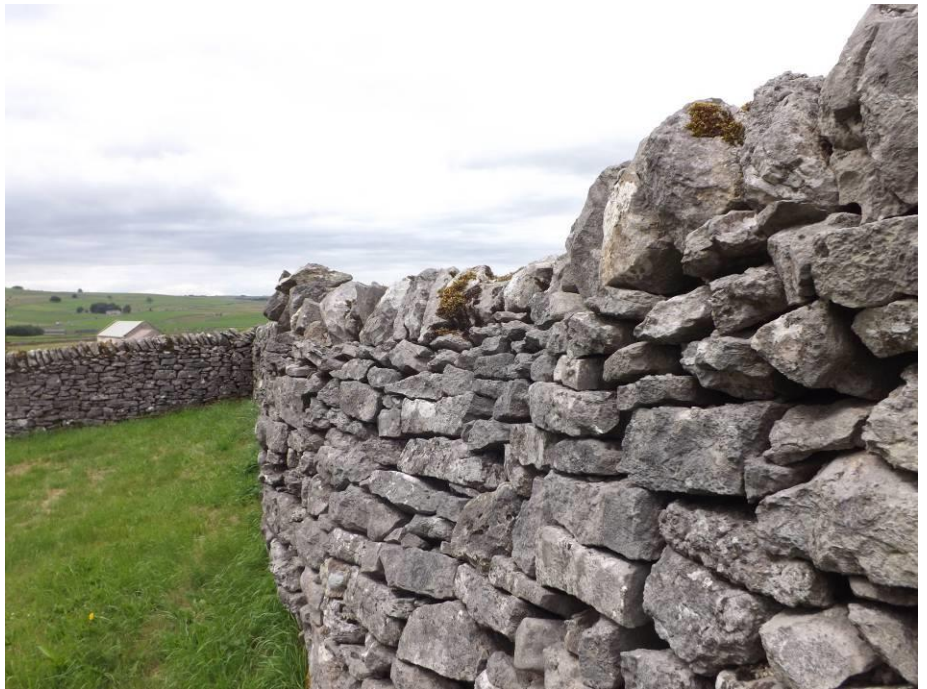
Sections of the stone walling have deflected or collapsed. The boundaries to the field are in poorer condition than the remainder.

Deflected boundary wall

ACTION: Obtain quotations from competent building contractors for the repairs required to the boundary walls.
