LEVEL 2

Your survey report

Property address
XXXXXXX

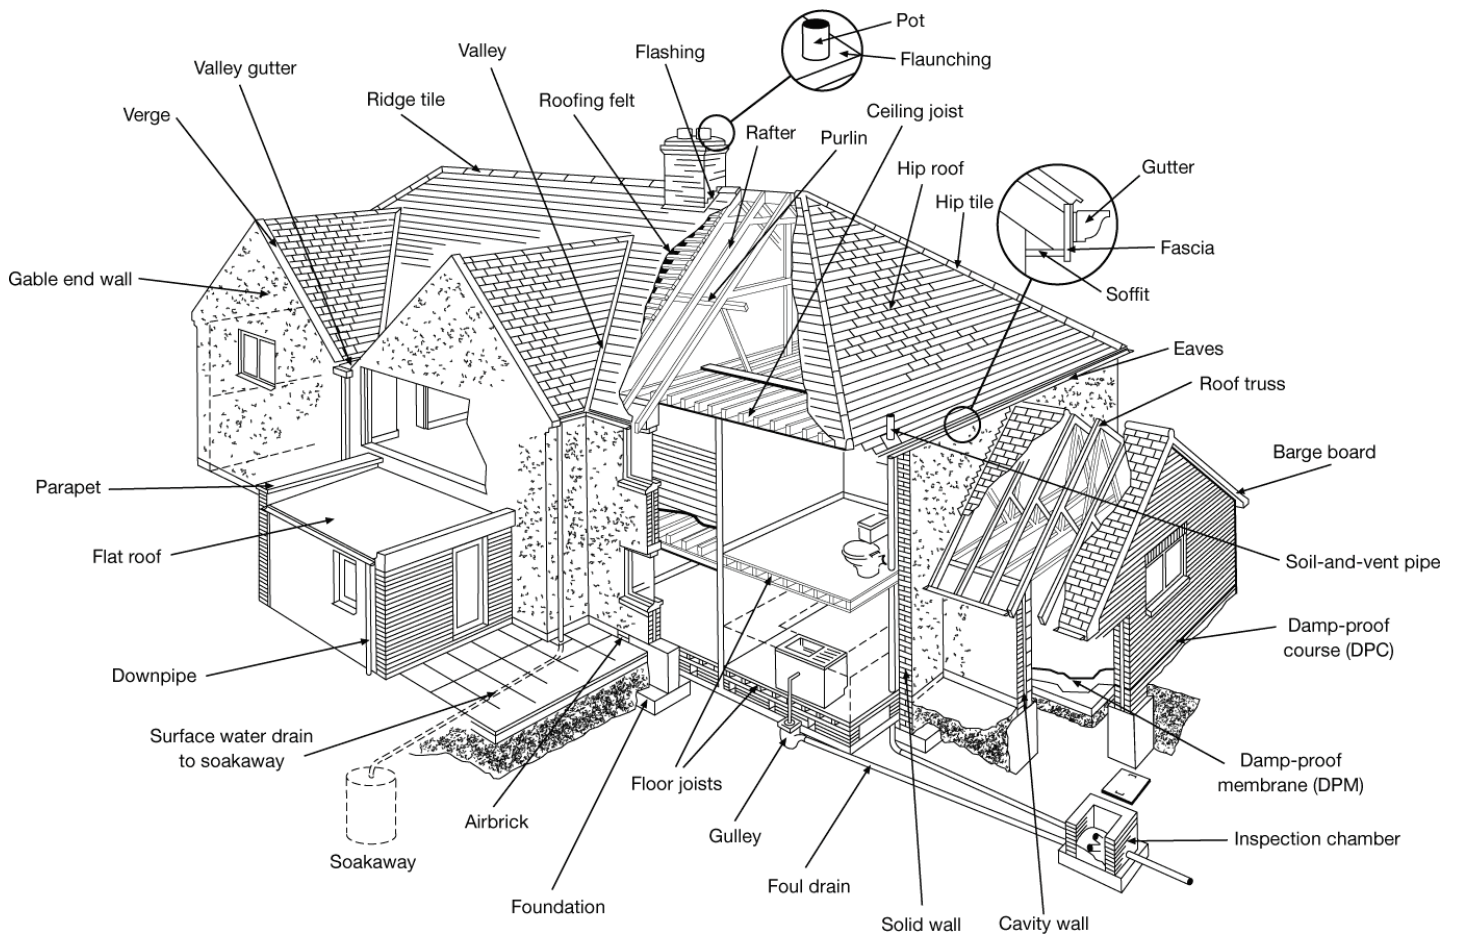
Typical house diagram

This diagram illustrates where you may find some of the building elements referred to in the report.
